60t Crane Rollover

ALERT STATUS: Normal
DATE ISSUED: 08/08/2017 10:43:48
INCIDENT No: 01463

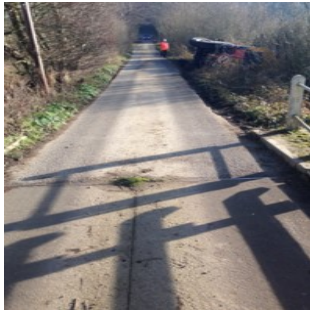
The road is very narrow with foliage on one side, and a soft verge and 5 foot deep ditch on the other. A rut had developed at the roadside and it appears that the front wheel of the crane dropped into this.

Access Road

- Effective journey planning would have identified a different route to site
- Keep away from unmarked edges and soft roadside verges

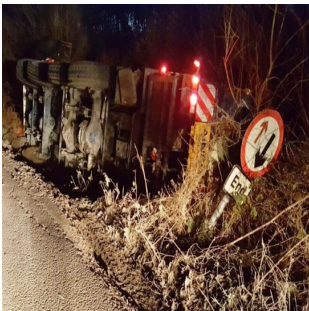
The driver continued onwards and tried to steer the crane out of the rut, but was unsuccessful; the trailing wheels also dropped into the rut and eventually the soft verge gave way, causing the crane to overturn.

- The crane was being driven at low speed and both occupants were wearing their seat belts; thankfully they only sustained very minor injuries.
- The driver was breathalysed by the Police and found to be below the legal limit.

Overtuned Crane

- Wearing a seat belt and not carrying any loose equipment in the cab will help to prevent injuries
- Journey Planning should be undertaken for all deliveries, and could identify where an alternative / safer route is necessary. In this case a movement order had been applied for but had not been issued. The Police had instructed the crane provider to use an alternative route but this had not been communicated to the driver.
