# Catwalk failure on mobile screener

## WHAT HAPPENED

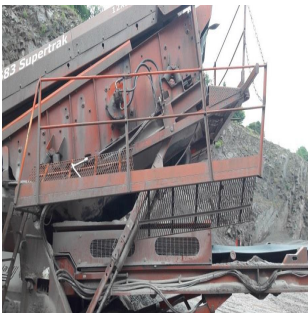
Photo 1

The kickboard side of the catwalk had torn away from the upper support rail and he fell through the collapsed floor. He received a laceration to the back of his head which required 3 staples in A&E.

**Photo 1** shows the collapsed catwalk after the incident. It is designed to fold up for transportation. Whilst this is not a new machine it was still in original condition around the catwalks. The screener was subject to regular inspection and the staff say that the catwalk was stable and gave no indication that it was likely to collapse before the incident. There was no movement, sway or bounce when it was in use.

- Both screeners had remedial repairs undertaken using a heavier gauge steel than the original construction to prevent future damage.
- Inspect similar equipment for defects and take remedial action where necessary.
- Amend inspection regimes to include an examination for this type of fault, where necessary.

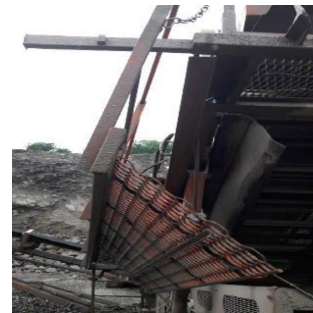
Photo 2

**Photo 2** shows the catwalk collapsed in on the rail that should support it.

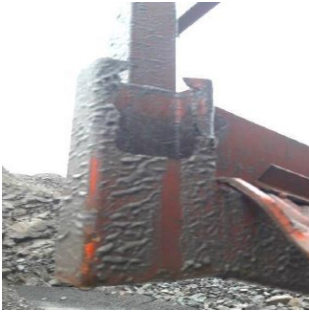
Photo 3

**Photo 3** shows the area where the walkway upright tore away from the support rail. Both the supports for the catwalk were damaged in the incident. A thorough examination of the other catwalk showed a hairline crack in the metal beside the weld once the paint was removed. Another screener was inspected following this incident and it was found to have a 10mm hairline tear in the steel at one of the upper supports once the paint was removed. Continued vibration during use appears to be the reason for the damage occurring.
