# Asbestos Gasket Alert

LOCATION:	OTHER	ALERT STATUS:	Normal
ACTIVITY:	MAINTENANCE & HOUSEKEEPING	DATE ISSUED:	25/01/2018 15:12:19
SUB ACTIVITY:	N/A	INCIDENT No:	01480

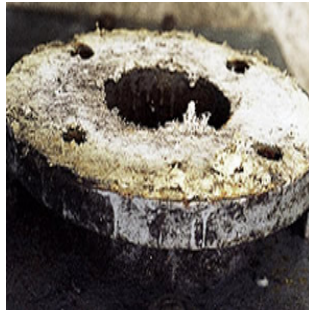
The photo demonstrates an example of an asbestos gasket (not the one in this case)

Example of an Asbestos Gasket

The Health and Safety Executive (HSE) prosecuting told the court that the company had failed to identify in the risk assessment for this job that there were asbestos gaskets attached to the non-return valve.

HSE also told the court that records held on site, which could have helped identify the presence of asbestos, were not adequate and that the maintenance team leader involved in this task had not undertaken asbestos awareness training.
