Confined Space - Serious Near Hit

LOCATION:	AGGREGATE DREDGER	ALERT STATUS:	Normal
ACTIVITY:	MAINTENANCE & HOUSEKEEPING	DATE ISSUED:	19/02/2019 10:32:13
SUB ACTIVITY:	N/A	INCIDENT No:	01505

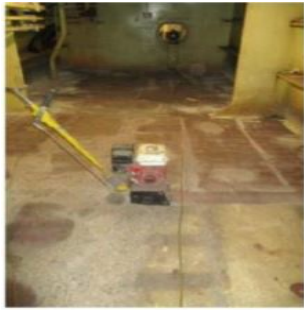
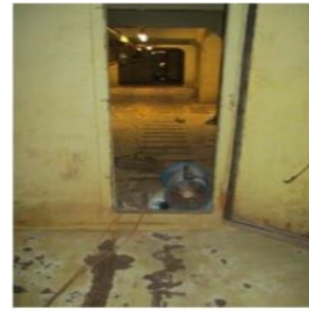
The task involved using a power scarifier to clear paint and rust from steel surfaces. The tank was gas free and certificated before work commenced with a yard entry certificate running for 24 hours. Initially the contractors used an electric 110v scarifier unit, but as they moved along the voids they encountered power drop issues on the electric unit with the length of power leads used. The contractors changed from the electric motor unit to a petrol engine unit and continued working throughout the day.

On leaving site they reported feeling dizzy and unwell and visited the local hospital, where they were found to have high carbon monoxide blood readings and were placed on oxygen for 2 hours before being discharged. The carbon monoxide was created from the exhaust of using a petrol machine in an enclosed space.

- No company personnel were informed of the near hit until the following day;
- Risk assessment did not include the use of power tools or the petrol scarifier;
- The permit issued from the yard did not include petrol equipment.
