# Contractor loses 4 fingers during lifting operation - £400K fine for company

**READYMIX OR MORTAR PLANT**  
**LIFTING**  
**NO SUB ACTIVITY AVAILABLE**

**ALERT STATUS:** Normal  
**DATE ISSUED:** 12/09/2019 19:42:46  
**INCIDENT No:** 01527

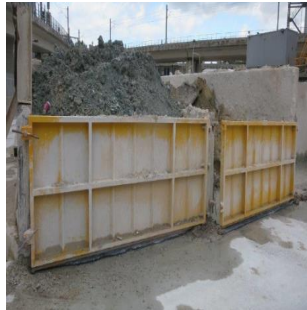
A site maintenance manager instructed a contractor to fabricate three new gates for some waste material bays at a readymix plant. The contractor and a colleague were fabricating the 3rd of the 3 gates at the plant (see pictures below). Whilst trying to flip the metal gate over using a fork lift truck and lifting chains, the metal gate slipped and trapped one of the contractor's fingers on his right hand.

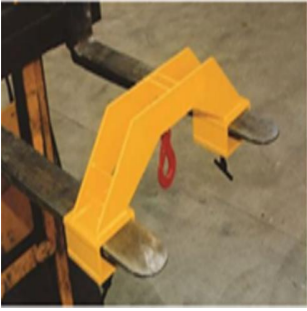
**Correct lifting device**

- Ensure attachment (picture example below) is used when using slings or chains on FLT to prevent the load from moving.
- Ensure there are clear procedures / processes on site to prevent unauthorised access to mobile plant. Where contractors are required to use items of mobile plant, a copy of their competencies MUST be held seen on induction.

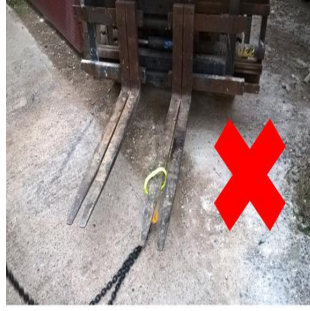
**Sixth opportunity to stop this incident** All lifting operations MUST have a Lift Plan which details any lifting attachment required. The investigation revealed the following; That no lift plan had been completed for the lifting operations to flip the muck gate over. As a result of this, the correct equipment was not selected for the lifting and slinging of the muck gate. One of the contractors was a trained lifting and slinging operator. The P2P identified lifting and slinging, but the absence of the lift plan was not challenged when issuing the P2P. Inappropriate lifting equipment was used to sling the muck gate, using chains with no FLT slinging attachment. The lifting chains were attached to the FLT forks (see picture below) which allowed the muck gate to slip when the forks were lifted.

**Lifting device used in incident**
