Contractor loses 4 fingers during lifting operation - £400K fine for company

ALERT STATUS: Normal
DATE ISSUED: 12/09/2019 19:42:46
INCIDENT No: 01527

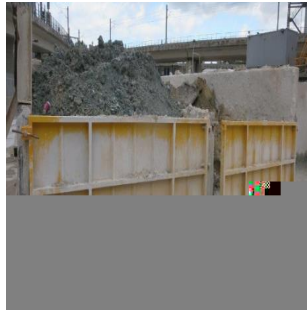
A site maintenance manager instructed a contractor to fabricate three new gates for some waste material bays at a readymix plant. The contractor and a colleague were fabricating the 3rd of the 3 gates at the plant (see pictures below). Whilst trying to flip the metal gate over using a fork lift truck and lifting chains, the metal gate slipped and trapped one of the contractor's fingers on his right hand.
