Hand Injury when maintaining conveyor - tool selection

LOCATION: AGGREGATE DREDGER
ACTIVITY: MAINTENANCE & HOUSEKEEPING
SUB ACTIVITY: N/A

ALERT STATUS: Normal
DATE ISSUED: 12/03/2020 15:30:19
INCIDENT No: 02553

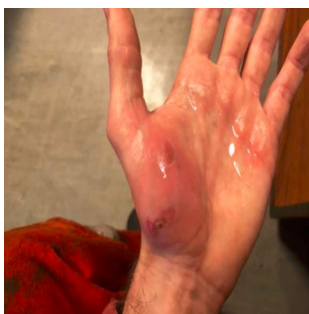
Whilst loosening the bolts, the IP was holding the spanner in place using the jaw end of the spanner, not the ring end. The spanner slipped and pinched the IP's hand between the spanner and the roller.

An investigation found that the root cause of the incident was the use of inadequate or improperly prepared tools. The IP suffered a compression injury, bruising and a break in the skin.

Image of injuries

- All Risk assessments that require the use of hand tools to be reviewed prior to commencing the task.
- To ensure that the risk of using hand tools is adequately documented and the correct tools have been selected and will be properly employed for the task.
