# Elevated Walkway Inspection

LOCATION: COMPANY-WIDE  
ACTIVITY: ACCESS & EGRESS & WORKING AT HEIGHT  
SUB ACTIVITY: N/A

ALERT STATUS: Normal  
DATE ISSUED: 17/08/2011  
INCIDENT No: 00299

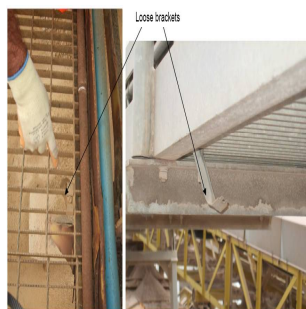
During a routine site visit it was noticed that a number of the brackets securing the mesh decking to walkway and platform steelwork were loose or missing. This could have lead to a person falling through an elevated walkway or platform and being injured.

Loose Bracket

- an urgent inspection of all types of elevated walkways & platforms should be undertaken
- these types of structures are included in your inspection & maintenance schemes.
