# Concrete Supervisor: Cement Burns

LOCATION: CONCRETE PRODUCTS PLANT  
ACTIVITY: MAINTENANCE & HOUSEKEEPING  
SUB ACTIVITY: N/A

ALERT STATUS: Normal  
DATE ISSUED: 04/11/2011  
INCIDENT No: 00314

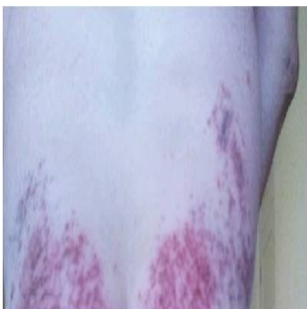
Whilst cleaning out the mixer on a concrete plant, vibrations caused cement held up in the chute and dust extractor to fall onto the Plant Supervisor's back. His colleague, who was on the outside of the mixer, noticed this and told him and so he immediately went to wash it off.

The Plant Supervisor then went straight home and had a shower. Initially there were no immediate signs of there being any symptoms but over the course of the weekend discolouring and soreness appeared.

Cement Burns

Fortunately, the Plant Supervisor was aware that contact with cement or freshly mixed concrete could result in chemical burns. If he had not taken immediate action the burns could have been much worse since chemical burns can develop without pain being initially felt. Dermatitis may also develop resulting in the affected skin becoming itchy, cracked and sore.

- Is the risk of chemical burns, including those caused by cement, considered in the site risk assessment and safe systems of work?
- Are relevant personnel trained in the risk of chemical / cementitious burns and the precautions that must be applied?
- Always wear the personal protective equipment (PPE) required as set out in the safe systems of work. In this instance one piece waterproof coveralls should have been worn.
- Always check PPE before commencing work.
- Stop anyone from working if they do not have the right, well maintained equipment, tools or PPE for the job.

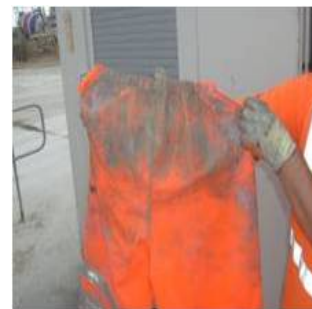
The Plant Supervisor was wearing a two piece waterproof suit which created a void at the lower point of his back as he was crouched down. This allowed cementitious material to drip down onto his bare back.

Waterproof Trousers
