# Truck Mixer Fall

LOCATION: TRANSPORT  
ACTIVITY: TRANSPORT & LOGISTICS / DELIVERY  
SUB ACTIVITY: PRODUCT DELIVERY

ALERT STATUS: Normal  
DATE ISSUED: 16/01/2012  
INCIDENT No: 00323

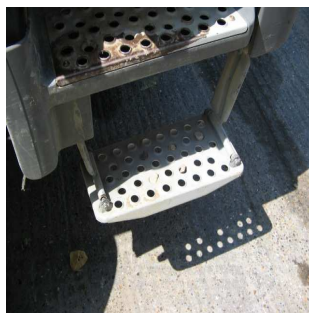
Bottom Steps

Whilst coming down from his cab, the driver caught his foot on the bottom step, twisted and fell to the ground.

The Panel of Inquiry could only conclude that the accident happened because the driver did not maintain 3 points of contact until both feet were firmly on the ground before turning to complete his other tasks.

The bottom steps, have been damaged on some vehicles and removed. Furthermore, some steps have been taken off before they get damaged because of the cost of replacement.

- Drivers must maintain 3 points of contact
  - Ensure vehicle steps provided by the manufacturer are on the vehicle
  - Ensure all vehicle steps are clean, free from debris and collision defects
-
