# Man Overboard

LOCATION:	AGGREGATE DREDGER	ALERT STATUS:	Normal
ACTIVITY:	MARINE OPERATIONS	DATE ISSUED:	08/01/2013
SUB ACTIVITY:	SHIP TO SHORE	INCIDENT No:	00354

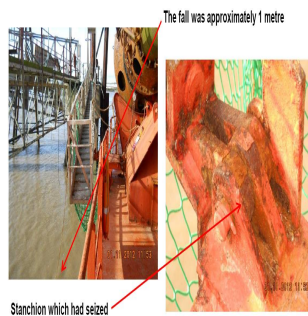
Whilst putting out the gangway, the Able Seaman pushed the support stanchion which gave way suddenly causing him to fall into the water alongside the ship.

Fortunately he was retrieved from the water quickly. Tide speed and water temperature could have easily made this incident far more serious.

- Failure to follow the Safe System Of Work – which clearly stated that lifejackets and harnesses should be worn when carrying out this task as well as placing a safety chain across the gap when during the activity.
- Failing to follow and review the Risk Assessment for the task.
- Maintenance procedures need to ensure that moving parts are in good working order.
