Load security

WHAT HAPPENED

ALERT STATUS:	Normal
DATE ISSUED:	09/01/2013
INCIDENT No:	00355

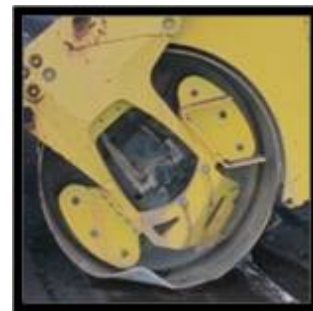
A 10 tonne Bomag 161-AD4 tandem vibratory roller slewed off a low loader trailer during a short journey from a compound to the site. The incident did not result in injury, but could quite easily have led to multiple fatalities as the machine came to rest on a pedestrian footway.

Considerable damage has been caused to the machine amounting to thousands of pounds. Whilst an in depth investigation into the events surrounding the incident is underway, initial findings cite the use of inappropriate restraining devices and the recommended machine tie down points not being used.

- Drivers are trained in loading and securing plant and machines:

- Appropriate restraining devices are used:
- they are checked before use for defects:
- they are capable of withstanding the load to be secured:

- The recommended tie down points are used on the machines:

- The recommended tie down points on the trailer are used:

- Whether it's a long or short journey, make sure it's secured properly.
