## Fatal 6 - Stored energy medical treatment injury - BMAPA Alert

**LOCATION:** AGGREGATE DREDGER  
**ACTIVITY:** MAINTENANCE & HOUSEKEEPING  
**SUB ACTIVITY:** N/A

**ALERT STATUS:** Normal  
**DATE ISSUED:** 07/01/2021 17:58:55  
**INCIDENT No:** 03581

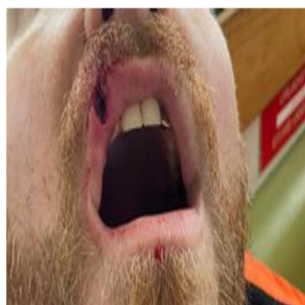
A conveyor belt contractor working onboard a UK marine aggregate dredger was engaged in turning the longitudinal belt which had flipped during operation. During the task the turfor clamp/hook became “stuck” between the conveyor frame and the rubber conveyor belt, the contractor then gave the chain to which the clamp/hook was connected a tug.

The clamp/hook freed more easily than he expected and as the IP was standing directly beneath the hook and was pulling the chain towards himself it contacted his right upper lip.

A second contractor, who was working above the IP and close to the stuck hook could have assisted with the freeing of the hook but wasn’t asked to

In the toolbox talk prior to the task starting, a discussion took place regarding being hit by a moving object where is stored energy is present, and that safe practices would be adopted such as standing clear of any snap back areas, ensuring sufficient grip/purchase is obtained on the belt and using tools where the operation of increasing the load on the tool is clear of the person operating it so that a failure or slip would not cause injury.

- Risk Assessments for working on conveyor belts must be reviewed and consider the hazard of being struck by moving object/tools when fastening and removing turfors from a clamped position.
  - Ensure close supervision and staff adopt a safe method of working as it will be specific to the location and tools in use.
-
