# Contractor gets alkaline dust in eyes and respiratory system

**LOCATION:** CEMENT PLANT  
**ACTIVITY:** MAINTENANCE & HOUSEKEEPING  
**SUB ACTIVITY:** N/A

**ALERT STATUS:** Normal  
**DATE ISSUED:** 06/01/2022 17:26:25  
**INCIDENT No:** 03601

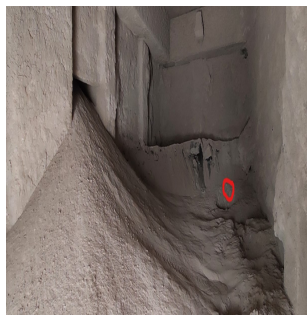
During a kiln shutdown, industrial cleaning contractors were vacuuming dust from inside the kiln dust room. Suddenly a large amount of material poured into the room via the inlet chute, filling the air with a thick cloud of dust. All three contractors in the room managed to make their way to the exit. While doing so, one of the contractors stumbled and fell, which led to alkaline dust entering his eyes and respiratory system.

The cause of the inflow of material is thought to have been a blockage in the inlet chute that suddenly released itself while the contractors were in the room. This potential hazard had been underestimated during the planning and risk assessment of the job. With hindsight, it is recognized this assessment relied too heavily on the fact that this had never happened before rather than whether or not it could happen

Spillage of dust

- The corrective action following the incident is to install a slide valve into the chute which will be closed during entry into the room to completely eliminate the possibility of dust blockages or build-up releasing and entering to room.
- When planning a task and undertaking risk assessments consider what potentially could go wrong rather than relying on previous experience of the task.
