# Risks of ordnance on the seabed - Report on recent incident BMAPA Alert

**ALERT STATUS:** Normal  
**DATE ISSUED:** 24/01/2022 15:32:40  
**INCIDENT No:** 03602

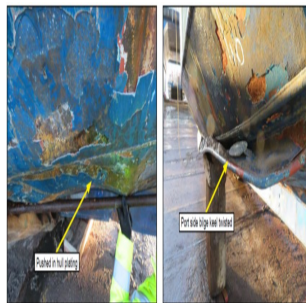
While recovering a string of crab pots during daylight hours, the line became snagged on a seabed obstruction – now believed to be a WWII German 250kg high explosive air dropped bomb – which subsequently detonated on the seabed 30m below the vessel. The resulting shock wave and gas bubble from the explosion struck the fishing vessel causing extensive deformation to hull plating, the engine room to be flooded and severe shock damage to all internal compartments.

Damage to hull

**THERE IS NO SUCH THING AS A 'DUD'** – and the fact that an item has been disturbed and moved does not mean that it is 'safe'.

Any munitions or ordnance discovered onboard aggregate dredgers or at wharves must be reported in accordance with the principles set out in the guidance **'Dealing with munitions in marine sediments' (2010)**, produced by the British Marine Aggregate Producers Association (BMAPA), the Mineral Products Association (MPA) and The Crown Estate in consultation with the police, Health & Safety Executive (HSE), Maritime & Coastguard Agency (MCA) and Joint Services Explosive Ordnance Disposal (EOD).

The principles contained within this guidance should be embedded within company policies, practices and procedures for every vessel and wharf where this potential risk exists.

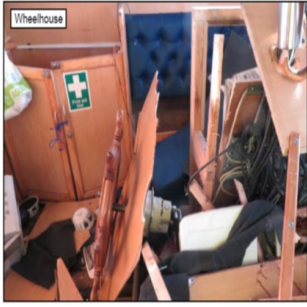
Damage to wheelhouse
