Fatal 5 - Failure of wire rope on rising skip

CONCRETE PRODUCTS PLANT
LIFTING
NO SUB ACTIVITY AVAILABLE

ALERT STATUS: Normal
DATE ISSUED: 01/02/2022 18:46:36
INCIDENT No: 03605

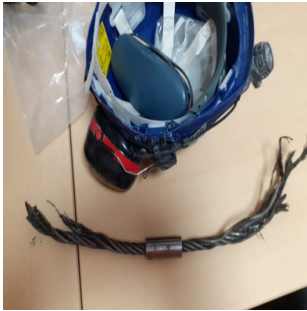
During the normal operation of the casting skip, the skip had begun its ascent. During its climb, the slack wire rope switch triggered and sounded. At this point the rope snapped on both sides and the skip fell to the bottom of the pit. It is not known whether the skip had reached its full height, however the skip was still full of aggregate so had not got to the stage of emptying.

- The wire rope had been rubbing on the side of the plates housing the rope and the skip wheels.
- Over a period of time, this could have caused the rope to become damaged, hence both ropes snapping at the same time.
- Ordinarily, the design is such that should one rope fail the other will hold the skip and prevent it falling.

Broken wire

- Ensure a robust PPM in place for inspection and replacement of ropes within all types of manufacturing equipment, both for safety of people and production equipment.
- Ensure a Statutory Inspection undertaken for safety critical ropes
- On inspection of the ropes, check for wear due to rubbing and engineer out any problems if identified.
- Ensure a robust lubrication process is in place for ropes and wires

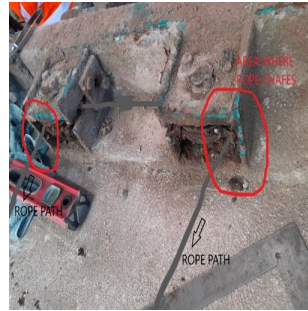
Where the wire rope was rubbing
