# Driver falls from access ladder on mixer truck

**LOCATION:** READYMIX OR MORTAR PLANT  
**ACTIVITY:** ACCESS & EGRESS & WORKING AT HEIGHT  
**SUB ACTIVITY:** N/A

**ALERT STATUS:** Normal  
**DATE ISSUED:** 23/05/2022 14:10:28  
**INCIDENT No:** 03617

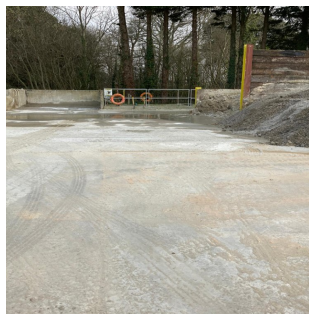
After washing down the truckmixer chute from the rear platform at the end of the day, an independent haulage contractor descended the ladder. On stepping down to the ground, the driver misjudged the floor level, lost his balance and fell, in doing so he fractured his wrist.

- Housekeeping and ground conditions were good
- The wash area was free from slurry
- There was good natural lighting in the area.
- The drivers PPE was in good order including his boots.
- The drivers had been inducted to site.
- The drivers CPC was up to date and he is in possession of MP Connect Card.
- Video evidence showed the driver was not rushing.
- The access ladder was in good order.
- The truck was clean and tidy with no defects.
- Monthly inspections of the truck are undertaken.
- The driver has 24 years experience.

Area where incident occurred

The incident acted as a reminder that the following questioned should be reviewed on a regular basis

- Are get a grip principles practiced and enforced?
- Are there robust inspections schemes and maintenance programmes in place?
- Are wash areas regularly inspected and cleaned?
