Slips, trips and falls - 2 incident involving falls on a quarry crusher

WHAT HAPPENED

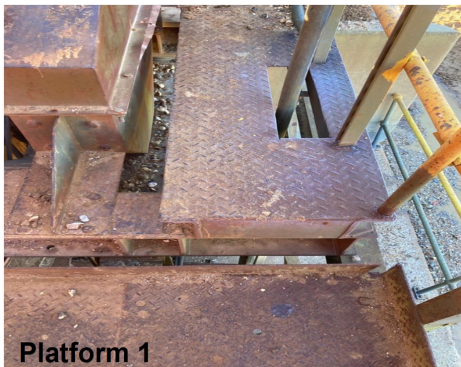
1st incident - An employee was checking to see if there was a fault on a quarry crusher. As he left the area, his boot lost grip due to the wet conditions and he fell backwards, landing on the crusher walkway with his head striking the kickplate. This resulted in a laceration to the back of his head which required 7 stitches and glue to seal the wound.

- All personal protective equipment (PPE) including boots were in good order.
- Change of levels in the areas presented tripping hazards.
- The areas were restricted for space.
- The areas were wet.
- Relevant inductions, Take 5 assessments and permits were completed.
- Housekeeping was good and areas clear of debris.

- Are flooring surfaces and hand holds appropriate for the working environment?
- Is the area for the task level and free of tripping hazards with sufficient space to carry out the task?
- Are there opportunities to make improvements to working areas to minimise the risk of slips, trips and falls?
- Are tasks that are likely to be carried out considered in the design of working areas?
- Are Get a Grip principles practiced and enforced?
- Is Take 5 used prior to doing non routine tasks?

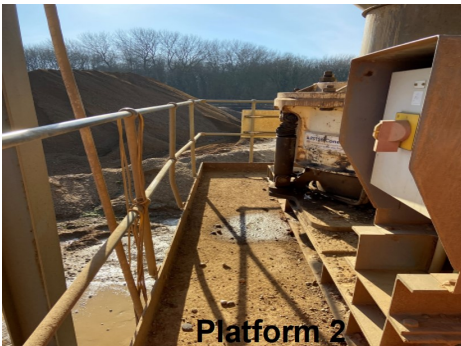
2nd incident - A contractor fell whilst manually guiding parts of the crusher that were being lifted in to place. He lost his footing as he stepped backwards, falling against the handrail, causing scrapes and bruising to his arm, including a puncture wound that required stitches.
