Slip trip and fall - Operator slips and sustains ankle injury on conveyor walkway steps

LOCATION:	QUARRY	ALERT STATUS:	Normal
ACTIVITY:	MAINTENANCE & HOUSEKEEPING	DATE ISSUED:	30/07/2023 20:19:38
SUB ACTIVITY:	CONVEYORS	INCIDENT No:	03654

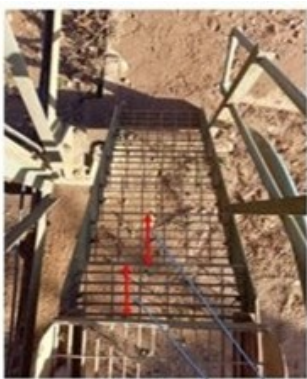
The injured person (IP) was completing daily maintenance checks and walked down the side of an incline conveyor, at the bottom, there are a set of six steps. As the IP approached the steps their right foot slipped forward off the top step causing the IP to perform a splits action and land on their left leg.

- HIRA and stop assessment in place for the task
- The IP was wearing full PPE gloves glasses and laced up boots
- IP maintained three points of contact and was not rushing
- No spillage on or damage to the steps
- The top step has a depth of 160mm, the remaining 5 steps have a 210mm depth, as highlighted in the picture above.

Going on steps 2-6 is 210mm
Going on top step is 160mm

- All steps/stairs to be reviewed on site
- Replacement of top step to ensure equal depth and width descending.
- Handrail added to conveyor side of steps
- Fitting of anti-slip treads on the individual steps
