Slip trip and fall - Operator slips and sustains ankle injury on conveyor walkway steps

LOCATION:	QUARRY	ALERT STATUS:	Normal
ACTIVITY:	MAINTENANCE & HOUSEKEEPING	DATE ISSUED:	30/07/2023 20:19:38
SUB ACTIVITY:	CONVEYORS	INCIDENT No:	03654

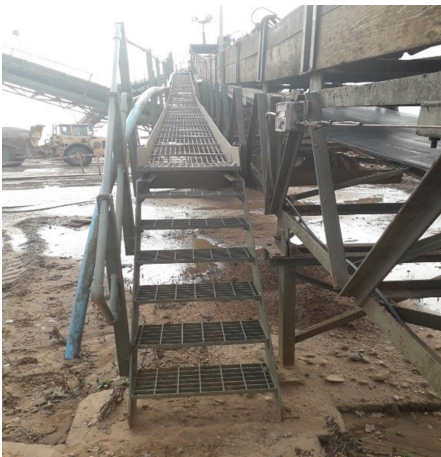
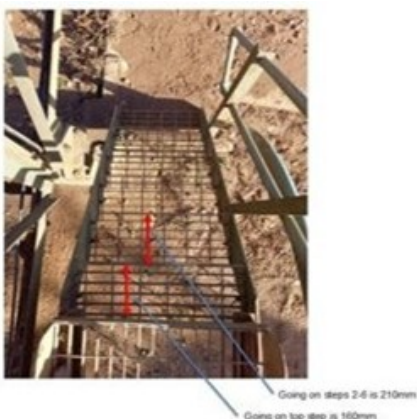
The injured person (IP) was completing daily maintenance checks and walked down the side of an incline conveyor, at the bottom, there are a set of six steps. As the IP approached the steps their right foot slipped forward off the top step causing the IP to perform a splits action and land on their left leg.

- HIRA and stop assessment in place for the task
- The IP was wearing full PPE gloves glasses and laced up boots
- IP maintained three points of contact and was not rushing
- No spillage on or damage to the steps
- The top step has a depth of 160mm, the remaining 5 steps have a 210mm depth, as highlighted in the picture above.

- All steps/stairs to be reviewed on site
- Replacement of top step to ensure equal depth and width descending.
- Handrail added to conveyor side of steps
- Fitting of anti-slip treads on the individual steps
