# Fatal 3 - Scaffolding contractor falls through gantry and fractures bones

<b>LOCATION:</b>	<b>QUARRY</b>	<b>ALERT STATUS:</b>	<b>Normal</b>
<b>ACTIVITY:</b>	<b>MAINTENANCE &amp; HOUSEKEEPING</b>	<b>DATE ISSUED:</b>	<b>06/08/2023 20:06:05</b>
<b>SUB ACTIVITY:</b>	<b>CONVEYORS</b>	<b>INCIDENT No:</b>	<b>03657</b>

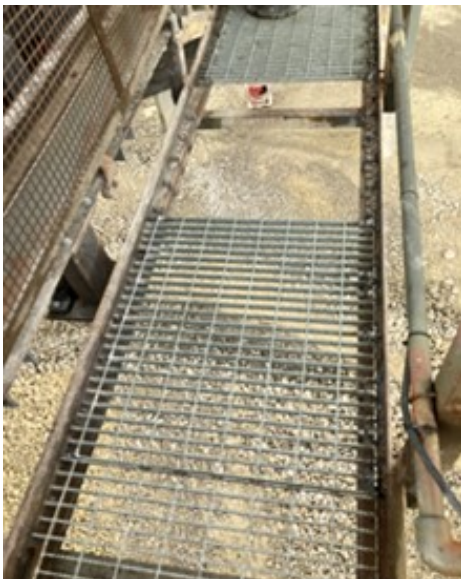
4 experienced scaffolders were dismantling a hanging scaffold that was supported off a conveyor structure, through the walkways either side. The scaffold, built at gantry level, was being removed and floor sections systematically replaced. As the task neared completion, the replacement of one of the sections had been overlooked. One of the scaffolders unclipped his lanyard and walked along the gantry and through the unprotected opening, falling onto a stockpile below. Despite fracturing 2 bones, the contractor is making a good recovery and will hopefully soon be back at work. The image below shows the missing section of flooring.

- Eliminate / reduce the need to work from height where there is a risk of falls.
- Ensure risk assessments, method statements and Permits to Work are specific to the task, with High Risk Permits for any high risk activities.
- Control access to areas where floor / edge protection is removed with hard barriers and effective work practices.
- Ensure fall protection equipment, safety harness and life lines, are always worn when working at height or near openings where there is a risk of falling.
