TRANSPORT - Fatal 2 - Loader strikes door of tipper whilst driver accessing vehicle - near miss

LOCATION:	RECYCLING PLANT	ALERT STATUS:	Normal
ACTIVITY:	LOADING AND UNLOADING	DATE ISSUED:	11/09/2023 13:43:52
SUB ACTIVITY:	NO SUB ACTIVITY AVAILABLE	INCIDENT No:	03663

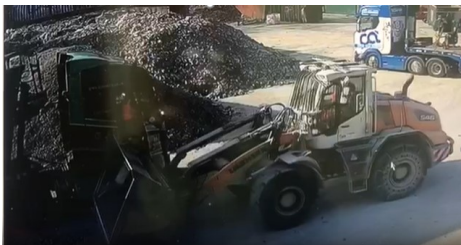
A wagon was being loaded with loose aluminium by a front end loader. On completion of loading, the shovel reversed away from the wagon and became stationary in the middle of the yard. Two pedestrians and a forklift truck passed the loading shovel in the yard, the loading shovel operator then proceeded to park adjacent to the loaded lorries cab door and spoke to the wagon driver. The wagon driver then exited the cab to check their external weigher. As he was climbing back in to his cab the shovel operator started to reverse and hit the lorry cab door, narrowly missing the driver.

- Yard rules not followed by members of staff. 'No go zone' entered on numerous occasion by forklift truck and pedestrians. Loader operator did not take charge of the yard and say no to access whilst loading operations taking place.
- Parked alongside the lorry, lack of hazard awareness of positioning when pedestrian in close proximity.
- Low loader operations were also taking place in the yard, providing a distraction to the loader operator and limiting space in the yard for loading to take place. No one was appointed to liaise with the low loader operations – and suspend other yard activities.

- Check all individuals working within yard are trained and competent
- Ensure that any Safe Systems of Work understood and are being followed
- Consider who is responsible for the safe operation and control of activities in yard
- Consider enforcements of 'no go areas' or 'exclusion zones around vehicles' during certain activities
- Ensure that loader operators are trained to recognise potential hazards and understand their responsibilities in terms of controlling other activities in yard
- When operating loaders or forklifts in yard remain alert to other activities and stop operations if necessary
- Consider warning systems on loaders and use of technology that could prevent collisions
- Ensure that appropriate risk assessments and SSOW are in place for loader operator.
