## Access & Egress Mobile Plant

**ALERT STATUS:** Normal  
**DATE ISSUED:** 01/08/2013  
**INCIDENT No:** 00367

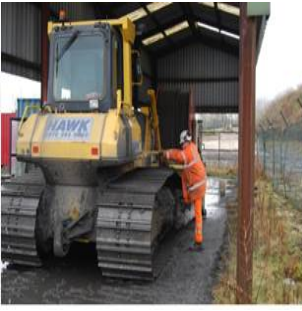
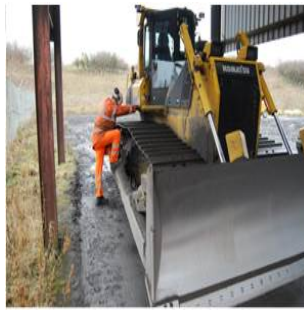
A mobile plant operator was climbing down from a bulldozer after cleaning the cab windows. He placed his left foot on the concrete floor when dismounting. When bringing his right foot down from the bottom step, his full body weight transferred and he went over on his left foot/ankle. This resulted in the injured person sustaining a fractured metatarsal in his left foot and a swollen ankle.

- The design of the bulldozer didn't allow for holding onto the handrail when making the final dismount onto the ground, encouraging a leaning body position and unstable dismount down to firm ground: When procuring new vehicles, plant and equipment, do we consider access requirements, involving operators where possible in evaluations? Do risk assessments and safe systems of work take into consideration access and egress arrangements, with modifications being specified /

undertaken as appropriate? Is plant inspected when it first arrives on site to ensure there is suitable access and egress? In this instance the bulldozer was off-hired following the incident and replaced by one with better access.
