Fatal 1 - Operator injured interacting with a trough roller

An operator's hand was lacerated when they attempted to remove a piece of aggregate

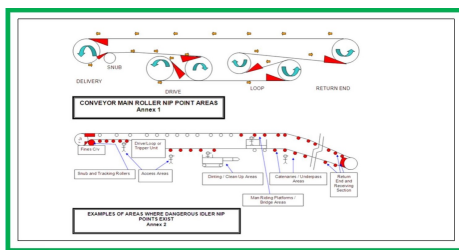
- Ensure you apply LOTOTO prior to interacting with any machinery. Never be tempted with "I'll just"....
- Review your risk assessments for conveyor safety and use a schematic as shown below to identify dangerous nip points.

- Please review the HSE guidance on **Belt Conveyor Fatal Nip Hazards - SPC/Tech/SI1/11** by following [this link](#).
