# Fatal 3 - TRANSPORT - Contractor falls from cab and injures his head

<b>LOCATION:</b>	<b>QUARRY</b>	<b>ALERT STATUS:</b>	<b>Normal</b>
<b>ACTIVITY:</b>	<b>ACCESS &amp; EGRESS &amp; WORKING AT HEIGHT</b>	<b>DATE ISSUED:</b>	<b>20/03/2024 14:28:06</b>
<b>SUB ACTIVITY:</b>	<b>N/A</b>	<b>INCIDENT No:</b>	<b>03702</b>

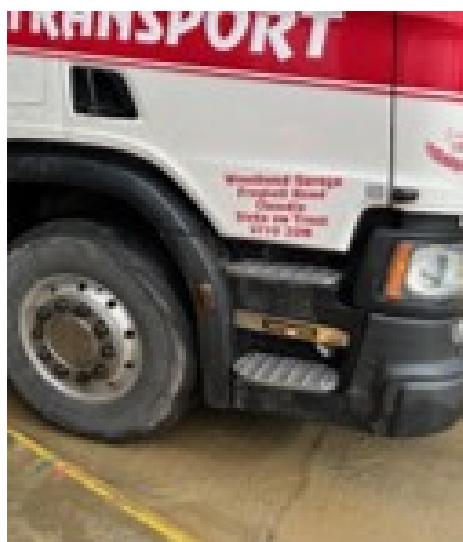
A contract haulage driver parked on site in preparation for loading of material. On exiting his vehicle cab, he misjudged his footing and missed the bottom step. He fell, striking his head, right elbow and lower back on the concrete paving. He received first aid treatment on site and his condition was monitored. He reported feeling dizzy and sick and therefore the Emergency Services were called. An ambulance arrived and the driver was taken to hospital for assessment, accompanied by the Plant Manager. He was released later in the day having had stitches to close his head wound.

**Vehicle** - The driver was familiar with the cab step configuration, it being his regular vehicle.

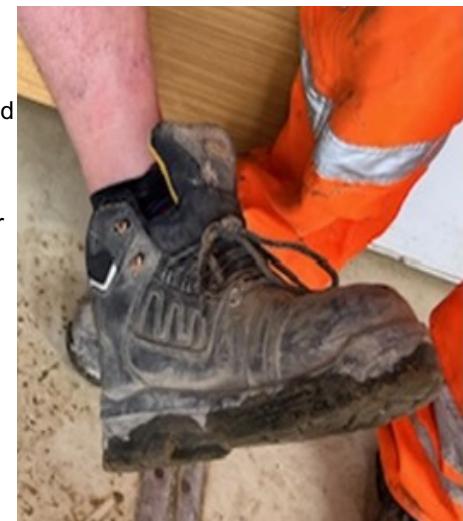
**PPE** - Although the driver was wearing boots they were not fastened correctly (see photo).

- Eliminate / reduce the need for drivers to get out of their cabs.
- Driver concentration, ensure 3 points of contact are maintained when getting in / out of vehicles.
- Footwear should be in good condition and worn correctly, laces fully tied.

- Assess if we can reduce the need for drivers to get out of their cabs through systems and engineering improvements.
- Review Risk Assessments and Safe Systems of Work (SSOW) relating to drivers' PPE and ensure all drivers are aware of the PPE requirements.
- Confirm all drivers receive and understand the requirements of updated SSOW.
