# Fatal 1 - Operator's hand drawn into rotating shaft of lathe

LOCATION: CONCRETE PRODUCTS PLANT  
ACTIVITY: MAINTENANCE & HOUSEKEEPING  
SUB ACTIVITY: LATHES

ALERT STATUS: Normal  
DATE ISSUED: 21/05/2024 17:25:23  
INCIDENT No: 03708

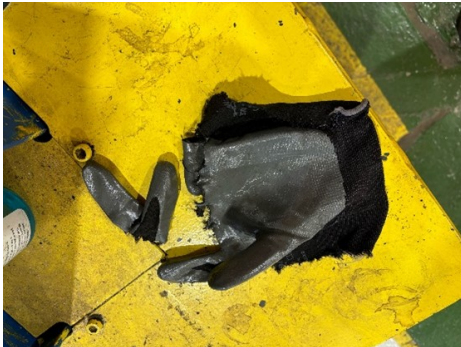
An operator's hand was drawn into a rotating shaft whilst holding emery cloth. The image of his glove below shows how lucky the individual was not to be seriously hurt.

The wearing of gloves increases the risk of entanglement and is never acceptable near rotating parts of machinery such as manual metal working lathes. The wearing of loose, baggy clothing, long hair and jewellery all increase the risk of entanglement.

- Always carry out a suitable and sufficient assessment of the risk from using emery cloth to polish or deburr a shaft. Methods of tooling are available that will achieve the surface finish or close tolerance required for the component.
- Emery cloth should never be applied by hand on manual lathes.
- If after completing a suitable and sufficient risk assessment, it is found that emery cloth does need to be used, there are tools on the market that allow this to be completed without holding the emery cloth by hand. HSE has some great guidance on safe working – links below. Please ensure you watch these

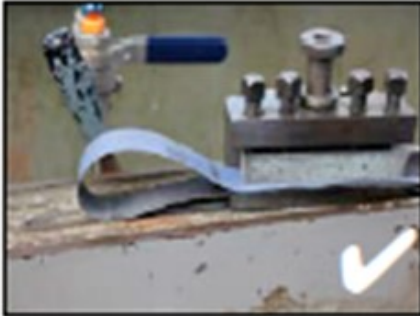
## Tool post

The tool post is used to clamp and hold a looped strip of emery cloth in place during application. (see video demonstration).

This method is for external deburring work only.
