FATAL 3 – TRANSPORT – Driver puts himself at risk of fall from height when cleaning mixer

LOCATION: READYMIX OR MORTAR PLANT
ACTIVITY: ACCESS & EGRESS & WORKING AT HEIGHT
SUB ACTIVITY: N/A

ALERT STATUS: High Potential
DATE ISSUED: 06/06/2024 18:14:30
INCIDENT No: 03716

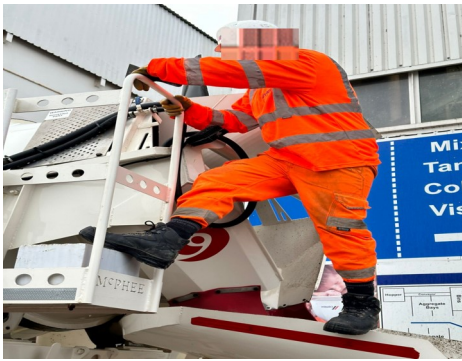
After returning from delivering the last load of slipform from a customer's site, where drivers are only allowed to dry brush their truckmixer chutes, the driver "stone washed" the drum. He noticed there was concrete build up on the "pig's ear". The driver parked his truck, isolated the vehicle and applied the wheel chocks, before climbing on the rear chute to remove the build-up.

Please see below image taken by another driver who **stepped in**

- **Look after yourself and others** - Stop and think behaviour not used.
- **Safe systems of work** - Driver induction training had been completed. Production had finished on the plant. No permit to work was issued. The activity is not included in the Independent Haulage Contractor (IHC) permitted vehicle maintenance activities.
- **Working at height** - Inappropriate access used for working at height.
- **Safety alert** - Recent HiPo Safety Alert involving similar vehicle Working at Height not effectively communicated
- **Take 5 / Risk perception** - At no point was a TAKE 5 pre task risk assessment completed

- Use of **TAKE 5 / STOP & THINK** approach.
- Compliance with site procedures, including obtaining a Permit to Work from a company representative and the requirement for supervision.
- Follow **ERIC P hierarchy** and risk assessment principles to identify the safest method of work.
- By completing the task another way, using mobile safety steps, scaffold tower or Mobile Elevated Work Platform (MEWP).
- Ensuring relevant Safety Alerts are effectively communicated and understood.
