Transport - Tipper driver injures leg when walking into Armco barrier

LOCATION: READYMIX OR MORTAR PLANT
ACTIVITY: TRANSPORT & LOGISTICS / DELIVERY
SUB ACTIVITY: DELIVERING AGGREGATES

ALERT STATUS: Normal
DATE ISSUED: 27/08/2024 12:20:26
INCIDENT No: 03730

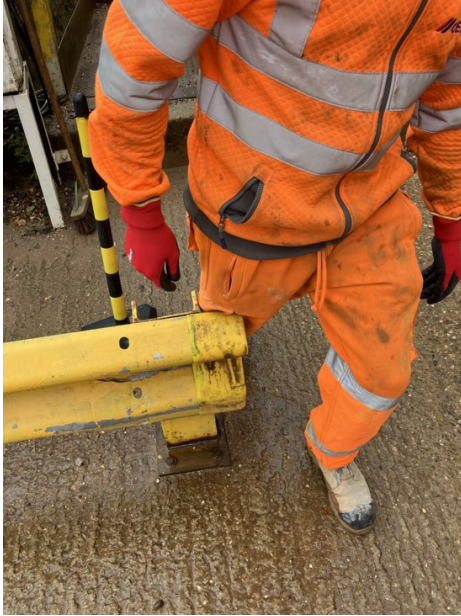
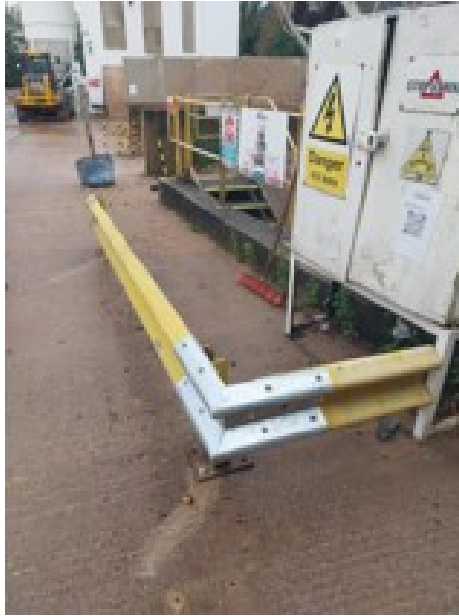
The exposed end of the Armco barrier was not protected. See below the before and after images, these show how a similar incident will be avoided by the changes made after this incident.

The driver didn't carry out a 'Take 5' assessment before delivering. If he had, he may have noticed the barrier and taken extra care around this area and highlighted the hazard via a Near Miss / Hazard Alert card.

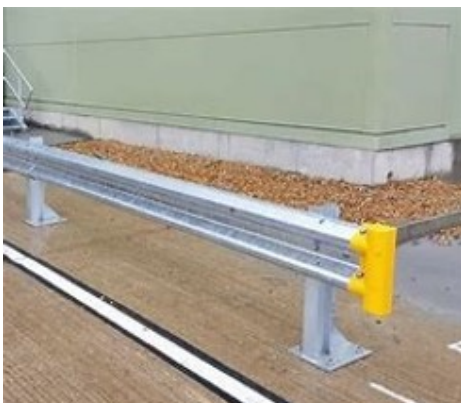
- Wherever possible, eliminate the need for driver / pedestrian movement on sites.
- Risk assess pedestrian areas for hazards such as slips, trips and falls, sharp edges, and unprotected pedestrian areas.
- Review pedestrian barriers to ensure there are no exposed sharp edges, for example by using end caps on Armco barriers, see image below.
