Fatal 5 - A stack of pallets containing precast concrete products collapsed as they were being prepared for loading onto a lorry

LOCATION:	CONCRETE PRODUCTS PLANT
ACTIVITY:	TRANSPORT & LOGISTICS / DELIVERY
SUB ACTIVITY:	DELIVERING CONCRETE PRODUCTS

ALERT STATUS:	Normal
DATE ISSUED:	11/09/2024 16:47:56
INCIDENT No:	03758

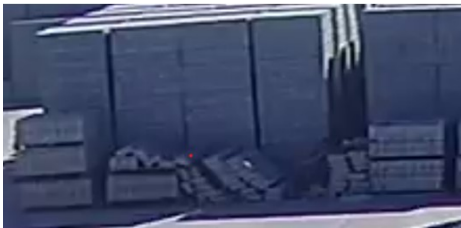
Whilst preparing products for loading onto lorries at a precast concrete stocking yard, a stack of pallets collapsed. It was lucky that no one was in the area when the incident occurred as they could have been seriously injured.

The incident was caused by several factors, including banding to a customer's pallets, which were of varying condition and sizes, and stacking too high.

In line with DVSA guidance the member company had initiated a policy of banding to pallets but was also doing a local collect customer a favour by banding to their pallets.

As the fourth pallet was being placed in a stack, the second pallet broke, allowing the top three pallets to tip to the side.

- In the future, the company will only use purpose-designed pallets and be more careful about how high they stack.
- Pallet loadings will be reviewed, and the safe loadings communicated within our teams.
