Contractor injured by high pressure hose when undertaking maintenance task

LOCATION: READYMIX OR MORTAR PLANT
ACTIVITY: MAINTENANCE & HOUSEKEEPING
SUB ACTIVITY: TANKS, KETTLE DRUMS AND PIPING

ALERT STATUS: Normal
DATE ISSUED: 02/10/2024 11:09:02
INCIDENT No: 04834

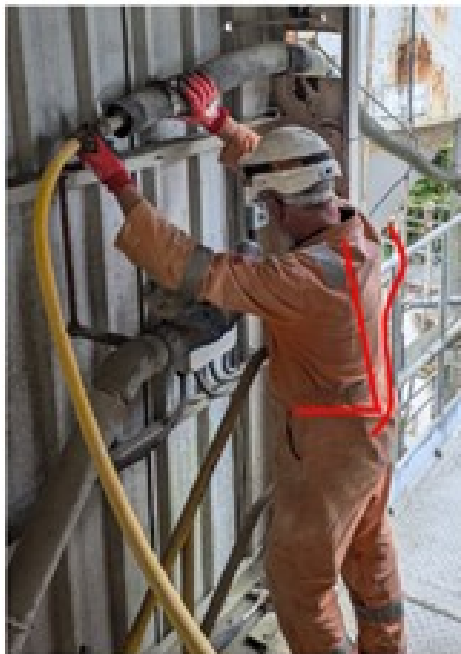
Initial Investigations indicated that the IP was undertaking a non-routine activity on site following maintenance on the recycled water tank pump. A stop assessment was conducted for the priming process. The IP proceeded to use a high-pressure water hose pipe to prime a 3" recycled water pipe. During the procedure the high-pressure hose unexpectedly recoiled whilst under high pressure, resulting in the IP's arm being forced backwards causing an injury to their shoulder.

Please see below two images that show the position of the contractor when the incident occurred.

- Check, confirm and review poor design which may cause positions of overreaching to ensure that ergonomic risks are considered and relevant controls are identified and implemented prior to the commencement of work.
- A stop assessment is not an adequate control measure for a non-routine task. A full Risk Assessment must be completed prior to work.
- Contractor management must include checks to ensure work is completed appropriately and in an operational state.
- Awkward postures refer to unnatural body positions, such as bending, twisting, or overreaching e.g. as seen below. These positions force your joints beyond their normal range of motion, significantly increasing the risk of ergonomic injuries.
