Fatal 5 - Truckmixer water hose incident.

LOCATION: READYMIX OR MORTAR PLANT
ACTIVITY: TRANSPORT & LOGISTICS / DELIVERY
SUB ACTIVITY: DRIVER AWARENESS

ALERT STATUS: Normal
DATE ISSUED: 02/12/2024 18:00:13
INCIDENT No: 04850

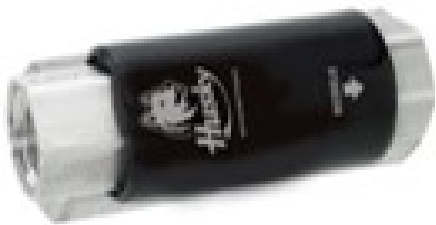
- Position the pipework such that the hose is as short as possible, ideally no longer than 5 metres.
- Fit magnetic couplings between the metal pipework and hose to act as a weak point and prevent a breakaway under force; the "T" piece to the pipework should be fitted in line with the direction of the hose coupling. See an example of a coupling below

Recommended magnetic coupling details:

- Re-usable magnetic coupling.
- Make / model: Husky #003385 Reconnectable Safe-T-Break
- Shock absorbing spring to stop nuisance breaks.
- Separates at under 200lbs to minimise backlash

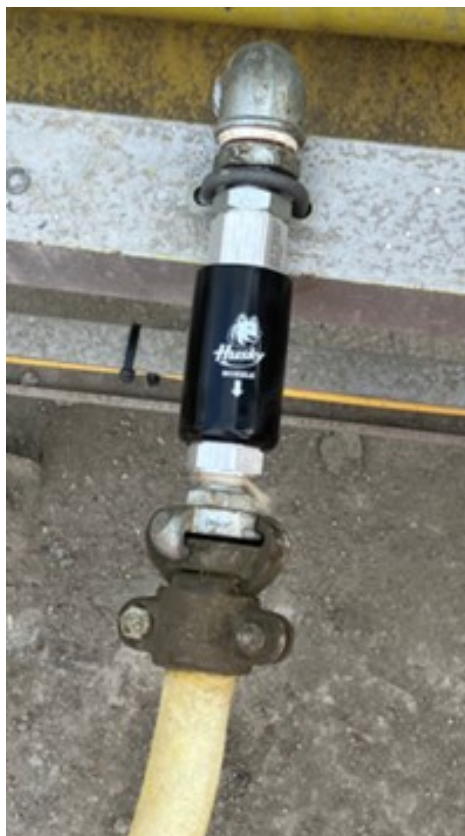
Image above shows a magnetic coupling in place and a typical example of a connection without one.
