**TRANSPORT - Fatal 2 - Adverse weather conditions - black ice - causes tipper to slide and strike staircase in stockyard, driver lucky to avoid serious injury - Video**

LOCATION:	READYMIX OR MORTAR PLANT	ALERT STATUS:	Normal
ACTIVITY:	TRANSPORT & LOGISTICS / DELIVERY	DATE ISSUED:	28/01/2025 20:21:56
SUB ACTIVITY:	DRIVER AWARENESS	INCIDENT No:	04857

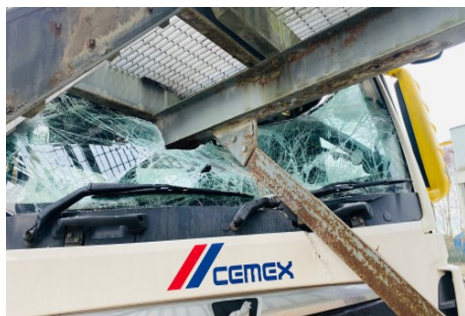
As the vehicle was entering onto the stocking area and making a left turn, it lost control on black ice, resulting in the vehicle impacting a staircase gantry.

- This incident reinforces the importance of implementing thorough winter preparations to maintain the safety of traffic routes.
- The vehicle was fitted with all the required safety features.
- The vehicle experienced a loss of traction on the icy surface during a left turn, which caused the driver to lose control. The weight of the trailer pushed the unit into the gantry of the staircase.
- The vehicle was travelling at a speed of approximately 7 miles per hour
- The pedestrian routes had been gritted; however, the traffic routes had not been considered
- An earlier incident occurred on the site a few hours prior, involving a vehicle that lost control due to the icy conditions.
- The driver wasn't notified of the ice present in the stockyard

- Evaluate the degree of risk associated with the icy conditions and, if required, limit access or shut down the site until it is deemed safe to proceed.
- In the aftermath of an incident, it is imperative to take prompt action to eliminate any hazards to prevent a recurrence.
- Site teams are advised to assess traffic routes to ensure that they are free from potential obstructions and that any vulnerable structures are adequately safeguarded with robust barriers or similar protective measures.
- Report and rectify identified issues associated with icy conditions promptly to prevent unsafe practices, ensuring that these issues are recorded in the near miss/hazard alert system.
- Stop, think and check it is safe, and always STEP IN if you see anything unsafe.

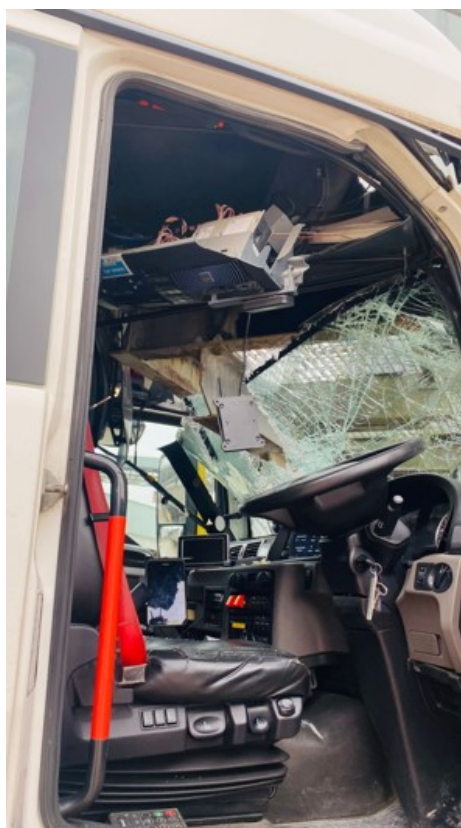
Fortunately, the driver was unharmed; however, the staircase penetrated the vehicle cab, which could have potentially caused serious injuries.
