TRANSPORT - Fatal 6 - Articulated truck rollover on soft verge

LOCATION:	ON-HIGHWAY	ALERT STATUS:	Normal
ACTIVITY:	TRANSPORT & LOGISTICS / DELIVERY	DATE ISSUED:	26/02/2025 18:18:01
SUB ACTIVITY:	ROLLOVERS	INCIDENT No:	04860

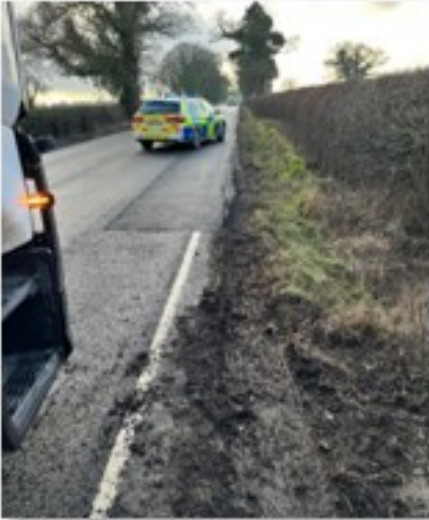
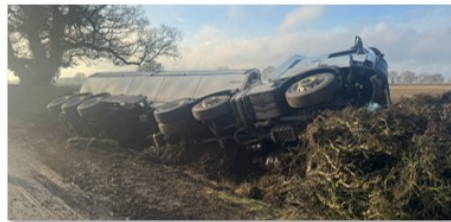
A loaded articulated truck rolled over when it veered off the road onto the soft verge. The image shows the tyre tracks where the vehicle left the road.

- The driver was wearing his seat belt.
- He was not using his phone at the time.
- He was travelling at 46mph (50mph limit).
- Weather was dry, visibility good, the road was dry.
- The white line, indicating the side of the public road, had not been repainted following re-surfacing

- Remaining fit and alert and maintaining driving skills with regular training and assessment; approximately 50k similar deliveries have travelled this route without incident in the last 4 years.
- Wider road and / or kerbs along this stretch of highway. Request the Council to re-paint white lines on the side of the road. Raise issue of soft verges with the Council again to see if improvements can be made.

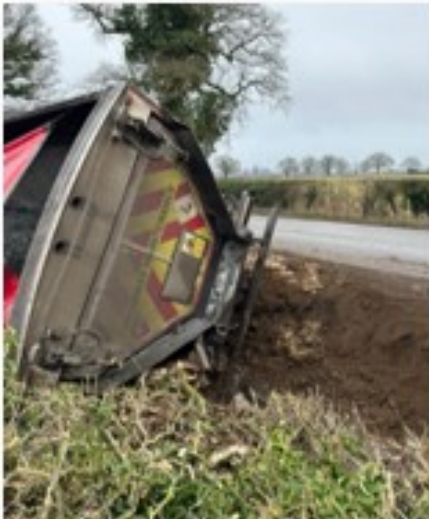
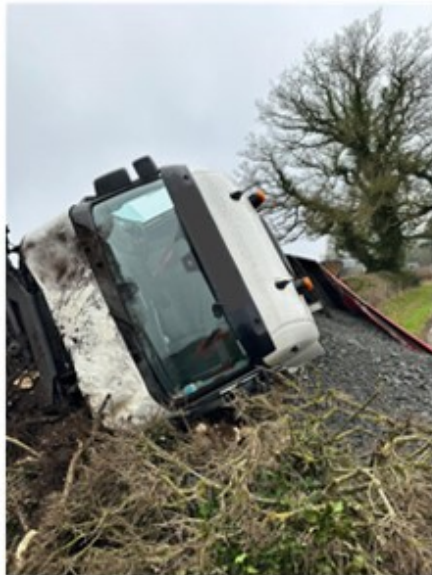
The vehicle ended up on its side in the ditch at the side of the road.
