TRANSPORT - Fatal 6 - Articulated truck rollover on soft verge

ALERT STATUS: Normal
DATE ISSUED: 26/02/2025 18:18:01
INCIDENT No: 04860

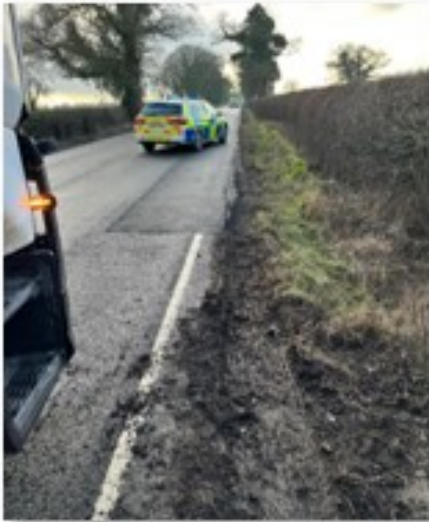
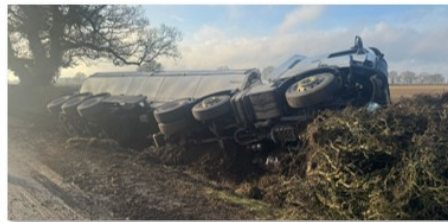
A loaded articulated truck rolled over when it veered off the road onto the soft verge. The image shows the tyre tracks where the vehicle left the road.

- Remaining fit and alert and maintaining driving skills with regular training and assessment; approximately 50k similar deliveries have travelled this route without incident in the last 4 years.
- Wider road and / or kerbs along this stretch of highway. Request the Council to re-paint white lines on the side of the road. Raise issue of soft verges with the Council again to see if improvements can be made.

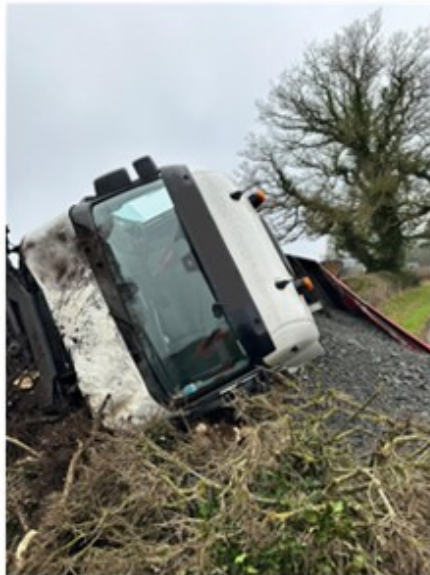
The vehicle ended up on its side in the ditch at the side of the road.
