# TRANSPORT - Fatal 6 - Debris stuck in a lorry's wheels was dislodged while driving on-highway and struck windscreen of another vehicle.

**LOCATION:** ON-HIGHWAY  
**ACTIVITY:** TRANSPORT & LOGISTICS / DELIVERY  
**SUB ACTIVITY:** TYRES AND WHEELS

**ALERT STATUS:** Normal  
**DATE ISSUED:** 23/03/2025 19:21:54  
**INCIDENT No:** 04863

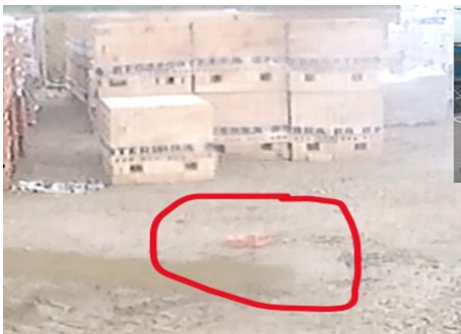
Further investigation revealed that the truck had run over some brick debris at the delivery point. A brick had lodged between the twin wheels on the drive axle of the vehicle, this was dislodged when the vehicle was traveling at speed on the motorway. This incident could have resulted in a fatality.

The images below shows an image of the debris in the yard and the damage to the windscreen

- Good basic housekeeping is a must in all our yards. We all look out for slip trip risks on a walkway, but now we are asking for your help to look out for the route the vehicles take to help keep these areas clear of debris.
- Drivers, please take care when maneuvering on site to not run over discarded bricks.
- If the above cannot be avoided and you are unable to move them, alert the yard manager or the nearest operative if you can.
- If you are left with no choice other than to drive over debris, check the space between the twin wheels before leaving site and only if safe, remove what you can or ask for advice / assistance from your ATM.
- If you require any further information, assistance or guidance please contact your Area Transport Manager.

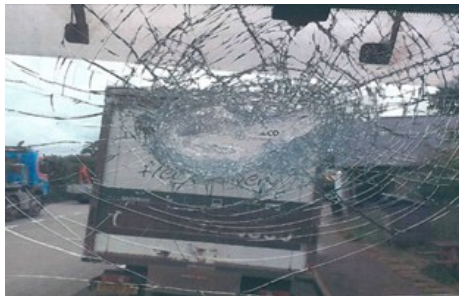
A company received a complaint that a brick had fallen from one of its vehicles and damaged the windscreen of another truck when driving on the public highway. On investigation, using the 3rd party truck footage, it was evident that the brick came from under the company's vehicle and not from the load area.
