# Damaged H.V. Cable in a quarry

## WHAT HAPPENED

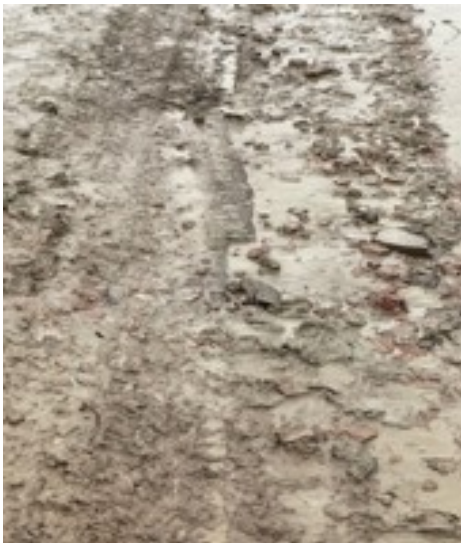
The quarry had a 11KV cable running through the haul road which had been buried some 9 or 10 years ago. Due to the gradual degradation of the roadway caused by the weather conditions and vehicles traversing it over the years, the cable ducting and cable had become raised and unprotected from the depth they were initially buried.

**Image of cable ducting beginning to be exposed.**

National Grid believe that the shovel had run over a boulder in the quarry which had forced the boulder edge through the shallow, buried ducting. The boulder had pierced both the ducting and the cable, causing the damage and shorting out the power supply to the surrounding area.

- Maintain haul roads for both safe operation of vehicles and correct depth when they go over buried services.
- Ensure that any underground services are provided with clear signage or markings so it is obvious where services are run – example signs below.

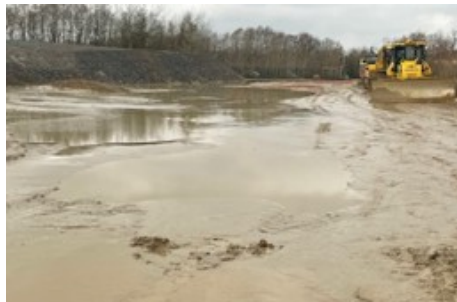
**Image of the haul road.**
