Learning Points form Pennyvenie Double Fatality

WHAT HAPPENED

ALERT STATUS: Normal
DATE ISSUED: 15/03/2012
INCIDENT No: 00329

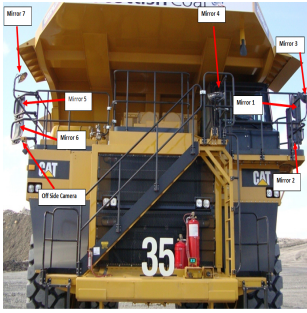
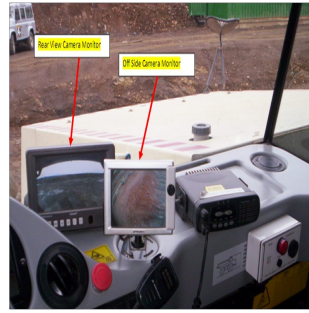
The tragic deaths of two maintenance fitters has focused attention on a range of key issues involving the interaction of heavy mobile plant and small soft-skinned vehicles. The pdf that is attached to this incident alert is a presentation that reconstructs the lead-up to the double fatality and gives an insight into the multiple learning points for quarry operators, concentrating on organisational behaviour; behavioural safety; heavy mobile plant design; and the huge consequential costs to an organisation.

Segregate heavy mobile plant & transport from people & light vehicles, wherever possible

Ensure conspicuity

Ensure all-round vision, but avoid driver sensory overload

Review driver training – never turn into ‘blind area’
