BEST PRACTICE

LOCATION:	Concrete products plant	ARTICLE YEAR	2016
ACTIVITY:	Access & Egress & Working at Height	COMPANY:	Brett Group
SUB ACTIVITY:	N/A	COMPANY LOCATION:	Brett Landscaping and Building Products
BEST PRACTICE No:	BP1950	COMPANY TEL:	0000
COUNTRY OF ORIGIN:	United Kingdom

Improving access to Penta tumble drum for maintenance works

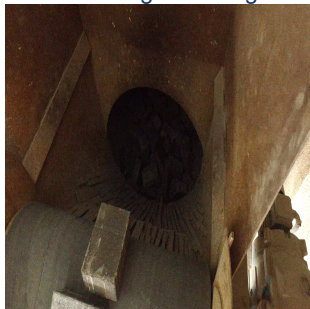
The original access to the drum was at height of 3.5m through the feed chute, it was accessed through the interlocked enclosure via narrow walkways and requiring the fitter to climb down 1.5m portable ladder in the feed chute before making their way along the drum. This created multiple problems:

Before

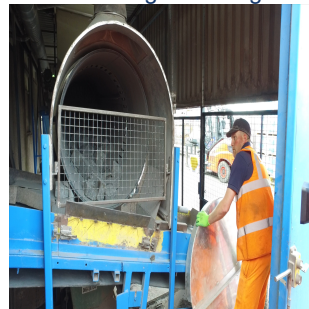
After

A pair of interlocked sliding doors were fitted to replace the solid enclosure guard at the discharge end. A lightweight aluminium discharge cowl was constructed. Following plant isolation and lock-off, the new cowling can be easily removed by a single fitter and stored safely to the side. Once removed, the tumble drum can be accessed using portable steps and the whole length of the drum can be easily seen by the 'topman' positioned at ground level.
