BEST PRACTICE

LOCATION: Mobile Plant **ARTICLE YEAR:** 2016
ACTIVITY: Traffic management **COMPANY:** Chepstow Plant International
SUB ACTIVITY: Quarry and earth moving **COMPANY LOCATION:** Panshanger Quarry
BEST PRACTICE No: BP1954 **COMPANY TEL:** 0000
COUNTRY OF ORIGIN: United Kingdom

Preventing articulated dump truck turnover

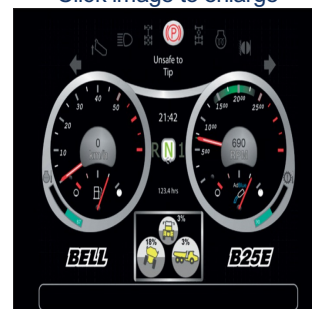
In cab display

The inclinometer programme is fully supported by in-house training, familiarisation and downloadable data should anything untoward occur. Both visual and sound warnings are included within the system, the system has variable settings that can be set by the company. The inclinometer system will hydraulically stop any "unsafe" tipping action, returning the skip to flat and level. The operator can then reposition the ADT before attempting to tip again.
