## BEST PRACTICE

LOCATION: Concrete products plant    ARTICLE YEAR: 2016  
ACTIVITY: Guarding and isolation    COMPANY: Creagh Concrete Products Ltd  
SUB ACTIVITY: No Sub Activity Available    COMPANY LOCATION: Toomebridge  
BEST PRACTICE No: BP1975    COMPANY TEL: 0000  
COUNTRY OF ORIGIN: United Kingdom

Edge Protection system

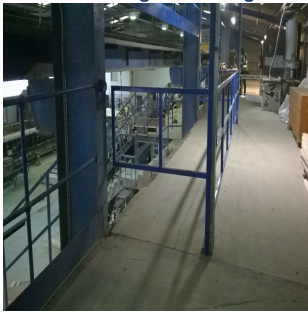
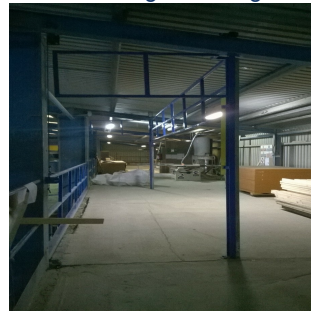
To address this risk, the managers at the site developed a counter balanced barrier system, when 1 barrier was lowered and the other was automatically raised or vice versa. The weight of 1 barrier mirrors the weight of the other, they are connected by a pulley system. The system is very easy to use. Normally, the edge barrier is deployed, when loading however, this is lifted and the loading bay area barrier is lowered into place.

A raised, mezzanine area at first floor level is used to build moulds for the casting of the precast stairs. Large pallets of timber are delivered to 2, designated loading bay areas on the mezzanine floor. A forklift truck raises the pallets from ground floor to the loading bays. Handrails were in place along of the edge of the mezzanine area but there were gaps by the loading bays to provide access for the forklift. Large straps were tied cross the opening to prevent a fall from height. However, this still left operators at risk as the bays were unguarded during loading, it also relied on the operators to attach the straps after every use.
