## BEST PRACTICE

| ACTIVITY: | Maintenance & Housekeeping | COMPANY: | Lagan Cement Group |

Device to reduce media displacement during cement mill discharge

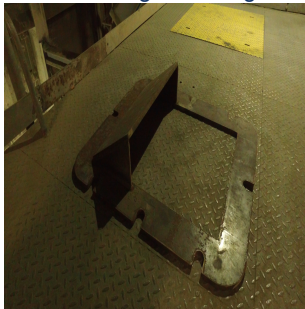
To address this issue, a deflector plate was manufactured and attached to the mill hatch. The deflector ensured that the balls would be guided safely into the containment area and minimised the impact on the plywood wall. The idea proved successful and reduced the spillage normally associated with re charge operations. See attached pdf of images.

Over previous annual shutdowns at Lagan Cement, emptying the media, six inch diameter steel balls, from the mill had proved difficult. As the mill rotated the steel balls would fall through the open hatch into the containment area, which was constructed with concrete blocks and plywood. Initially this temporary construction would contain the balls. However, as the mill continued to rotate, the repeated impact on the plywood from the balls reduced its effectiveness. Some balls would escape potentially damaging the hydraulic and water pumps located in the vicinity or their associated pipework.
