BEST PRACTICE

Penta tumble drum chute wear plate improvements eliminates confined space hot work

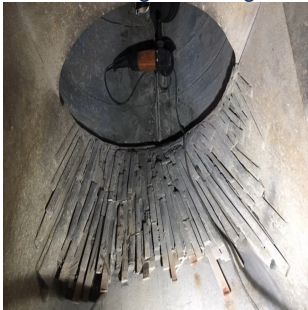
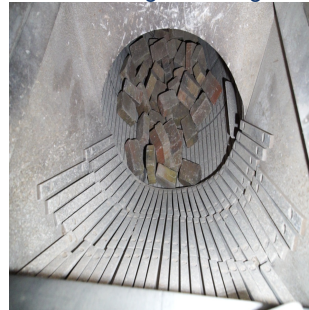
At Brett's site in Poole, the fully automated Penta Line 'ages' concrete block pavers by tumbling the cured blocks inside a rotating steel tumbler drum fitted with lifter bars. The tumbling action is extremely abrasive and causes both significant wear on the feed chute and drum, this is compounded by impact damage. The wear and damage are minimised by installing wear strips on the feed chute. However, the interior had to be inspected on a weekly basis and repairs made. This required operators to work in a confined space where hot work was undertaken such as welding to replace damaged wear strips taking about two hours.

The solution was to reinforce the tumble drum chute and fit bolt-in wear bars instead of weld-in wear strips. The bolt in wear bars were also extremely hard wearing. The bolts holding the strips in place could be undone from the outside. The installation cost was £ 4,300 with estimated annual costs of £3,350 per annum.
