LOCATION:	Concrete products plant	ARTICLE YEAR	2018
ACTIVITY:	Maintenance & Housekeeping	COMPANY:	Brett
SUB ACTIVITY:	N/A	COMPANY LOCATION:	Southampton
BEST PRACTICE No:	BP2019	COMPANY TEL:	0000
COUNTRY OF ORIGIN:

**Penta tumble drum chute wear plate improvements eliminates confined space hot work**

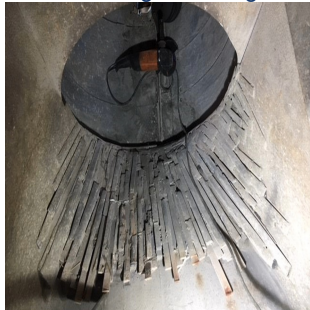
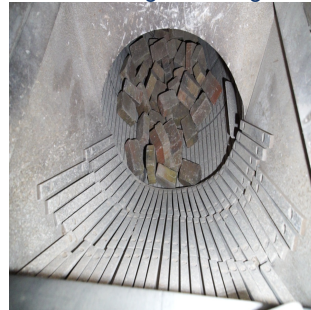
At Brett's site in Poole, the fully automated Penta Line 'ages' concrete block pavers by tumbling the cured blocks inside a rotating steel tumbler drum fitted with lifter bars. The tumbling action is extremely abrasive and causes both significant wear on the feed chute and drum, this is compounded by impact damage. The wear and damage are minimised by installing wear strips on the feed chute. However, the interior had to be inspected on a weekly basis and repairs made. This required operators to work in a confined space where hot work was undertaken such as welding to replace damaged wear strips taking about two hours.

The solution was to reinforce the tumble drum chute and fit bolt-in wear bars instead of weld-in wear strips. The bolt in wear bars were also extremely hard wearing. The bolts holding the strips in place could be undone from the outside. The installation cost was £ 4,300 with estimated annual costs of £3,350 per annum.
