## BEST PRACTICE

LOCATION: Concrete products plant  
ACTIVITY: Manual handling and storage  
SUB ACTIVITY: Aggregates  
BEST PRACTICE No: BP2021  
COUNTRY OF ORIGIN:

Elimination of manual handling & pinch point injuries

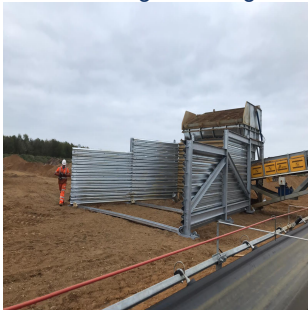
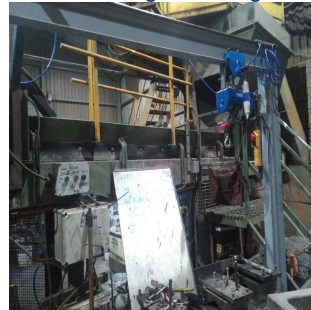
To eliminate both hazards an overhead beam together with a trolley fitted with an electrical winch were installed. The weight of the slipper was fully supported by the winch whilst it was moved into position. A handle was attached to the slipper, to aid finer positioning during installation, and lifting eyes to simplify connecting to the winch cable. A storage table for the slippers with lockable wheels was also introduced, the table can be moved along in line with the with beam.
