## BEST PRACTICE

LOCATION:	Quarry	ARTICLE YEAR	2018
ACTIVITY:	Maintenance & Housekeeping	COMPANY:	Aggregate Industries
SUB ACTIVITY:	N/A	COMPANY LOCATION:	Garside Sands
BEST PRACTICE No:	BP2024	COMPANY TEL:	0000
COUNTRY OF ORIGIN:

Field conveyor cleaning scoop

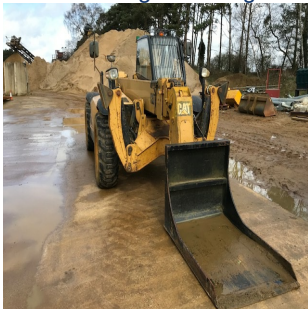
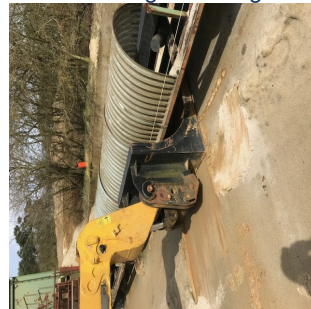
To overcome this problem and following a lengthy evaluation of the sites' conveying systems, the on-site maintenance team designed and built a scoop. This was designed to fit onto a CAT Telehandler which could insert the scoop under the conveyor

and remove spillage. The arm of the telehandler providing further flexibility and reach.

The 'Scoop' was constructed from an old loader bucket utilising a CAT quick hitch attachment. This enabled the 'Scoop' to be easily moved around the site when required.
