## BEST PRACTICE

LOCATION:	Cement plant	ARTICLE YEAR	2018
ACTIVITY:	Transport & Logistics / Delivery	COMPANY:	CEMEX UK
SUB ACTIVITY:	Product delivery	COMPANY LOCATION:	Grinding Plant Tilbury
BEST PRACTICE No:	BP2031	COMPANY TEL:	0000
COUNTRY OF ORIGIN:

Preventing vehicle tip overs

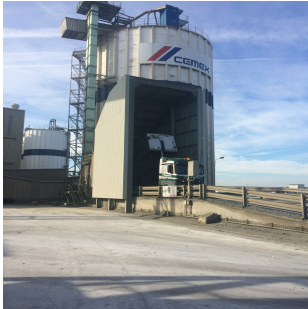
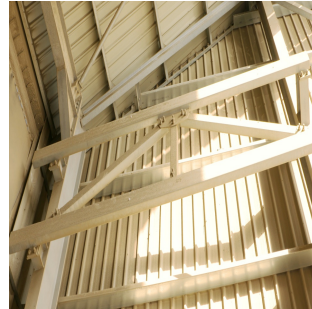
To prevent the possibility of this happening again, a covered tip over frame has been constructed. Vehicles now reverse into the fully covered frame and before they off-load into the safe tipping area. It is now impossible for vehicles to tip over regardless of weather conditions, mechanical failures such as a ram collapse or a tyre puncture.
