BEST PRACTICE

LOCATION:	Cement plant	ARTICLE YEAR	2018
ACTIVITY:	Transport & Logistics / Delivery	COMPANY:	CEMEX UK
SUB ACTIVITY:	Product delivery	COMPANY LOCATION:	Grinding Plant Tilbury
BEST PRACTICE No:	BP2031	COMPANY TEL:	0000
COUNTRY OF ORIGIN:

Preventing vehicle tip overs

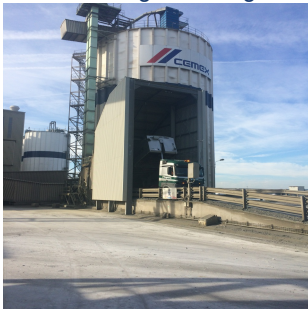
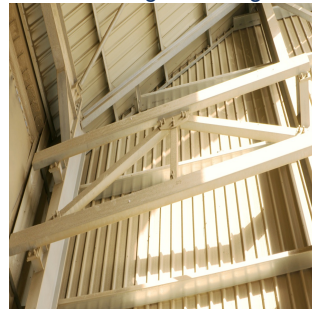
To prevent the possibility of this happening again, a covered tip over frame has been constructed. Vehicles now reverse into the fully covered frame and before they off-load into the safe tipping area. It is now impossible for vehicles to tip over regardless of weather conditions, mechanical failures such as a ram collapse or a tyre puncture.
