BEST PRACTICE

LOCATION: Cement plant
ACTIVITY: Transport & Logistics / Delivery
SUB ACTIVITY: Product delivery
BEST PRACTICE No: BP2031
COUNTRY OF ORIGIN:

ARTICLE YEAR: 2018
COMPANY: CEMEX UK
COMPANY LOCATION: Grinding Plant Tilbury
COMPANY TEL: 0000

Preventing vehicle tip overs

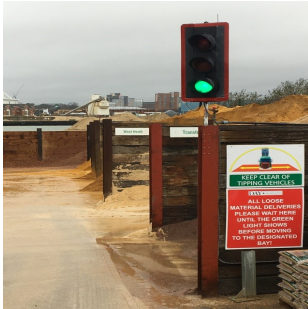
To prevent the possibility of this happening again, a covered tip over frame has been constructed. Vehicles now reverse into the fully covered frame and before they off-load into the safe tipping area. It is now impossible for vehicles to tip over regardless of weather conditions, mechanical failures such as a ram collapse or a tyre puncture.

CEMEX's grinding plant is located on the wharf at Tilbury docks, the site is exposed to strong south-westerly winds. A number of articulated tippers have been blown over as they were delivering raw material on the ramps into the apron belt feeders.
