LOCATION: Asphalt/Coating plant  
ACTIVITY: Maintenance & Housekeeping  
SUB ACTIVITY: N/A  
BEST PRACTICE No: BP2043  
COUNTRY OF ORIGIN:

ARTICLE YEAR: 2018  
COMPANY: CEMEX UK  
COMPANY LOCATION: Local Asphalt Sheffield  
COMPANY TEL: 0000

Trace heating for cold feed bins

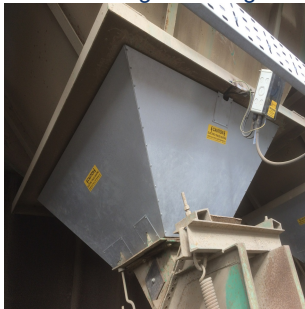
Working with Cross Electrical, (an Avetta vetted contractor) an insulated, cladded frame with thermostatically controlled trace heating was installed.

At CEMEX's Local Asphalt Sheffield plant, the traditional, steel framed feed bins are filled from above using a loading shovel. The sloped sides of the bin then enable the aggregate to flow under gravity. However, in very cold weather conditions the material can freeze and stop flowing. To clear the blockage, staff would be required to work at height to access the bins and attempt to clear it using manual handling techniques and tools.
