## BEST PRACTICE

LOCATION: Asphalt/Coating plant  
ACTIVITY: Maintenance & Housekeeping  
SUB ACTIVITY: N/A  
BEST PRACTICE No: BP2088  
COUNTRY OF ORIGIN:

ARTICLE YEAR: 2021  
COMPANY: FM Conway  
COMPANY LOCATION: Heathrow Asphalt Plant  
COMPANY TEL: 0000

Asphalt drum hydro blasting

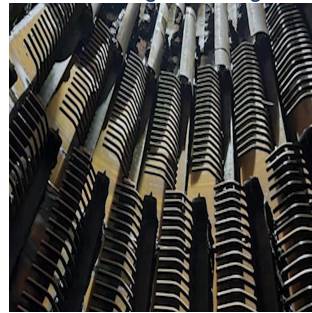
After

At FM Conway's asphalt plant at Heathrow, it was necessary to regularly remove the build-up of material sticking to the dryer finger lifters in the RAP drum. These fingers lift the material and drop it in front of the heat screen to allow the product to be heated and mixed correctly. Over time, the RAP drum clogged with old material blocking the finger lifters and cooled material stuck to the drum. This causes the plant to run less efficiently and results in more wear and tear on the components due to the increased weight of this material.

FM Conway developed a new system using pressure jets to achieve this.
